**Flood Control Project Maintenance
Levee Inspections**
LMA District Cover Sheet
Spring 2019 Levee Inspection Results

Reclamation District No. 0554 Walnut Grove

Spring 2019 Levee Inspection Results

Waterway			Bank	Unit Miles
Unit No. 01 Sacramento River			Left	1.13
	Spring (March - May)	Summer (June - August)	(September - November) Fall	Winter (December - February)
Unit Maintenance Rating (Fall Only)				
Date of Inspection	3/15/2019 - 3/15/2019			
DWR Inspector	David Julian			
Accompanied By

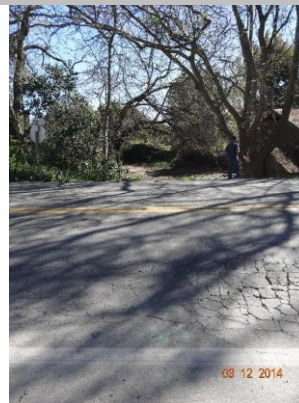
Photo 2 of 3 : UCIP_SP_2019_32022_58479.jpg

LM Start	0.89	Rating **	M	Issue No.	49 (cont)	
LM End	0.89	Issue Type +	En	Location *		
Category	Supplemental			GPS Latitude/Longitude		
				Start	End	
Item	DWR UCIP Field Study			38.238595 °	38.238595 °	
				-121.516945 °	-121.516945 °	
DWR ID	20942					
Comment Code						
Inspector Comment						
FS_ID:32022 DS_ID:20942 EP_NO: N/A Repair Type: Non-Urgent Crossing Status: Indicator Found UCIP Comments: Unable to confirm how many sewer lines cross levee. Desk study shows 2 crossings 4-inch not 6 inch. Need to contact owner to confirm status of crossing. FIELD_STRUCT_DESC: 2 of 2: 4-inch clay sewer pipe through the levee, 10.2 feet below the crown. (USACE-1959). This entry matches the Drainage or Irrigation Structure referenced in O&M manual (RM 26.50). FS Date: 3/12/2014

View of levee crown.

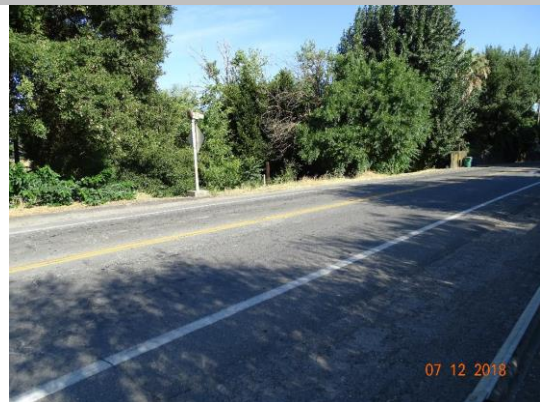
Photo 3 of 3 : UCIP_SP_2019_53406_77593.jpg

A 1-inch and a 1.5-inch galvanized iron drinking water pipe with shutoff valves at pumphouse on LS toe.

View of levee crown at the crossing.
